# Royalston Historic District Commission

## Application for Certificate

Address of Property: The Raymond School 3 Raymond Circle, Royalston, MA 01368

# Chimney at Raymond School

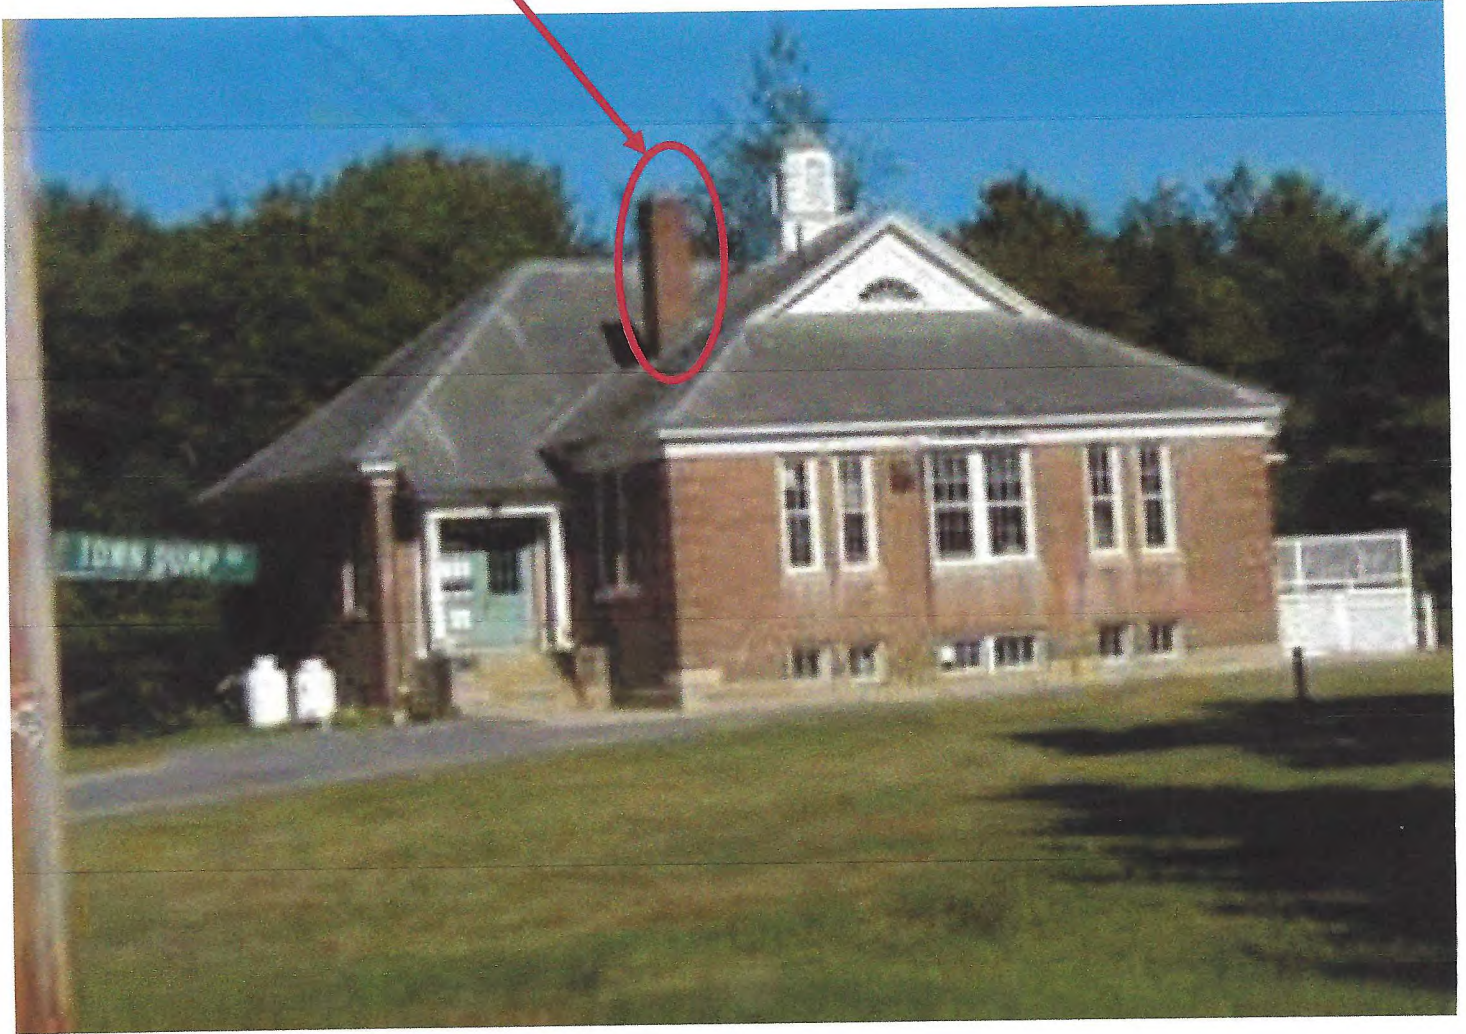
Because the asbestos roof shingles on the Raymond School are being removed and a new roof installed it is imperative that we remove the brick chimney before the new roof is installed. The non-functioning chimney will be a major heat loss to the building and a source of damage to the new roof. When the chimney is removed it will allow the attic to be insulated and isolated from the heated parts of the building, which will add to the overall energy efficiency of the Raymond School.

The chimney was part of the oil-fired heating system. Because the old furnace will be replaced by a non-fossil fuel heating system the chimney will no longer be needed. Leaving it in place will only have a negative effect on both the energy efficiency and the structural integrity of the building.

**Energy Efficiency:** When not used to exhaust gases from a furnace the chimney becomes a source of heat loss by wicking heated air out of the building. It also becomes a source of moisture penetration into the building and will require periodic maintenance so that it does not cause damage to the roof and rafters. The life of the new roof will be extended if there is no chimney.

**Structural Integrity:** Brick chimneys that are no longer part of a functioning heating system create a weak point in the building's envelope. The roofing, underlayment, base flashing, counterflashing, sheathing, and roof structure are all vulnerable to greater deterioration over time. This in turn increases both the cost of upkeep to the town and the damage to one of our historic buildings.
